Manhole Inspection Summary

Manhole # S25KK1006MH

Insp Date: **11/7/06 8:22 AM**

Location Address: **4401 HICKORY AVE**

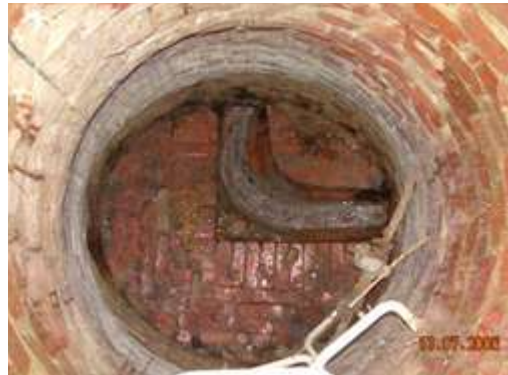
Top View

Condition: ☐ Sound ☐ Cracked ☐ Root Intrusion ☐ Loose Brick ☒ **Deteriorated**

Infiltration: ☐ None ☐ Joint ☐ Cracks ☒ **Mortar** ☐ Roots ☐ Wall

Surcharge ☒ **Evidence Of Surcharge** Depth: **2** (ft.) ☐ Active Surcharge Present

Barrel infiltration. Evidence of surcharge - Bench debris.

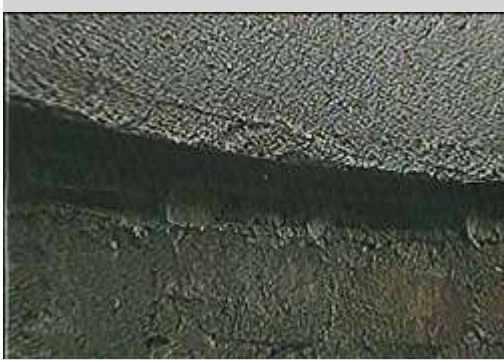
Defect

Frame Offset: **3** (in.) Condition: ☐ Sound ☐ Cracked ☒ **Leaks**

Infiltration: ☐ None ☒ **Joint** ☐ Cracks ☐ Mortar ☐ Roots ☐ Wall

Frame leaks. Adjustment infiltration.

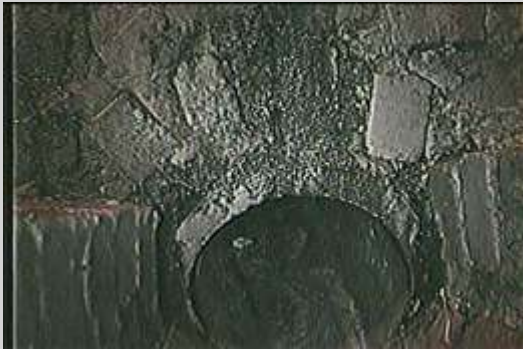
8 in. Circular Gravity Sewer Pipe Out @ 12 O'Clock

Barrel deterioration and infiltration.

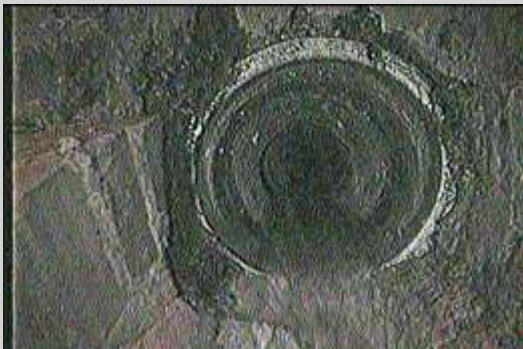
8 in. Circular Gravity Sewer Pipe In @ 3 O'Clock

Infiltration: **Evidence** Pipe Seal Cond: **Unknown**
